Manhole Inspection Summary

Manhole # S21A__036MH

Location Address: **1911 LANVALE ST**

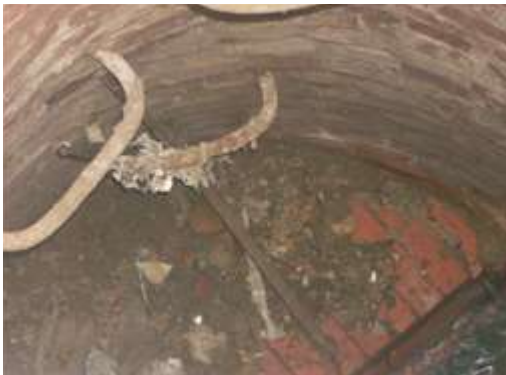
Defect 7

Surcharge ☒ **Evidence Of Surcharge** Depth: **2** (ft.) ☐ Active Surcharge Present

STEP SURCHARGE EVIDENCE

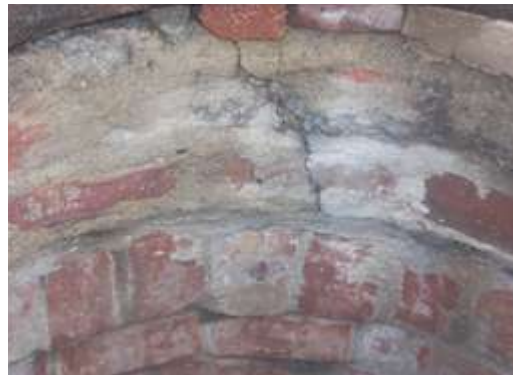
Defect 2

Condition: ☐ Sound ☒ **Cracked** ☐ Root Intrusion ☒ **Loose Brick** ☒ **Deteriorated**

CRACKED CHIMNEY AND LOOSE BRICKS

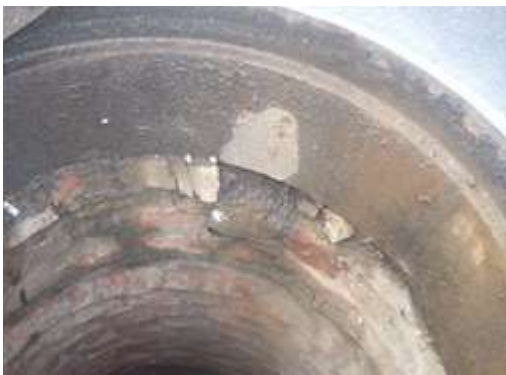
Defect 1

CHIMNEY DETERIORATION

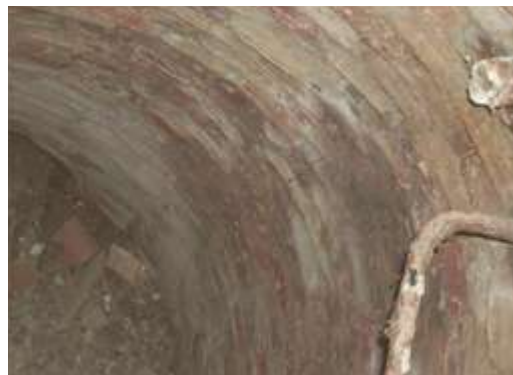
Defect 4

Infiltration: ☐ None ☐ Joint ☐ Cracks ☐ Mortar ☐ Roots ☒ **Wall**

BARREL INFILTRATION

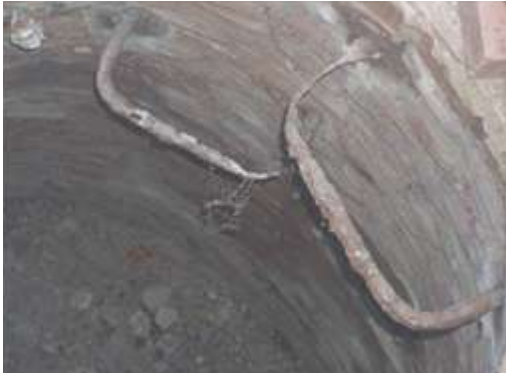
Defect 3

Steps Count: **4** Missing: **0** ☒ **Corroded**

MISSING AND CORRODED STEPS

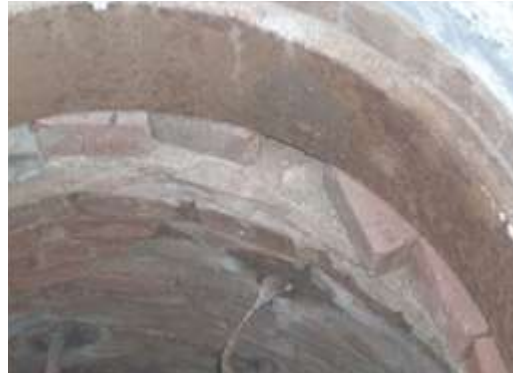
Defect 2

LOOSE BRICKS AND DETERIORATED CHIMNEY

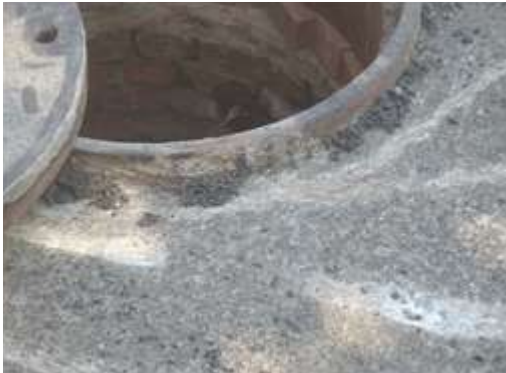
Defect 1

GRADE ADJ

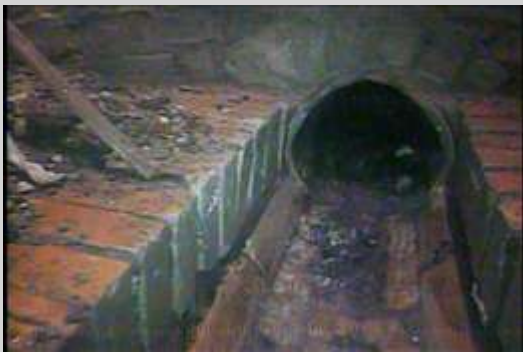
12 O'Clock Outflow

Pipe Height: **7.2** (in.) Rod and Bar (Angled)
Pipe Material: **Clay** ☐ Pipe Lined
Invert Depth: **8.34** (ft.) Flow Characteristics: **None**
Deposits: ☐ None ☐ Mud ☐ Sludge ☒ **Debris** ☐ Grease
Silt Depth: **3** (in.) Deposits Extent: **Medium**
Infiltration: **None** Pipe Seal Cond: **Sound**

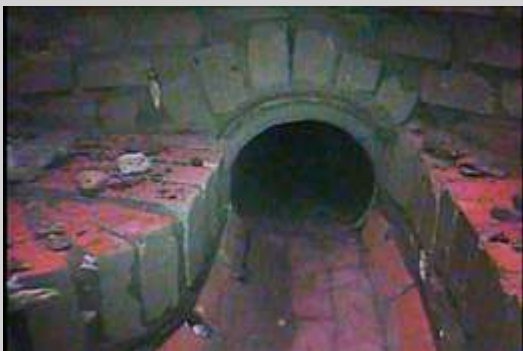
9 O'Clock Inflow

Pipe Height: **8.4** (in.) Rod and Bar (Angled)
Pipe Material: **Clay** ☐ Pipe Lined
Invert Depth: **8.50** (ft.) Flow Characteristics: **Slow**
Deposits: ☒ **None** ☐ Mud ☐ Sludge ☐ Debris ☐ Grease
Silt Depth: (in.) Deposits Extent:
Infiltration: **None** Pipe Seal Cond: **Sound**
